FLOOD EMERGENCY PLAN

Ball Mountain Lake

**FLOOD EMERGENCY PLAN
FOR
BALL MOUNTAIN LAKE**

Prepared By:
CLEVERDON, VARNEY & PIKE, INC.
Consulting Engineers & Architects

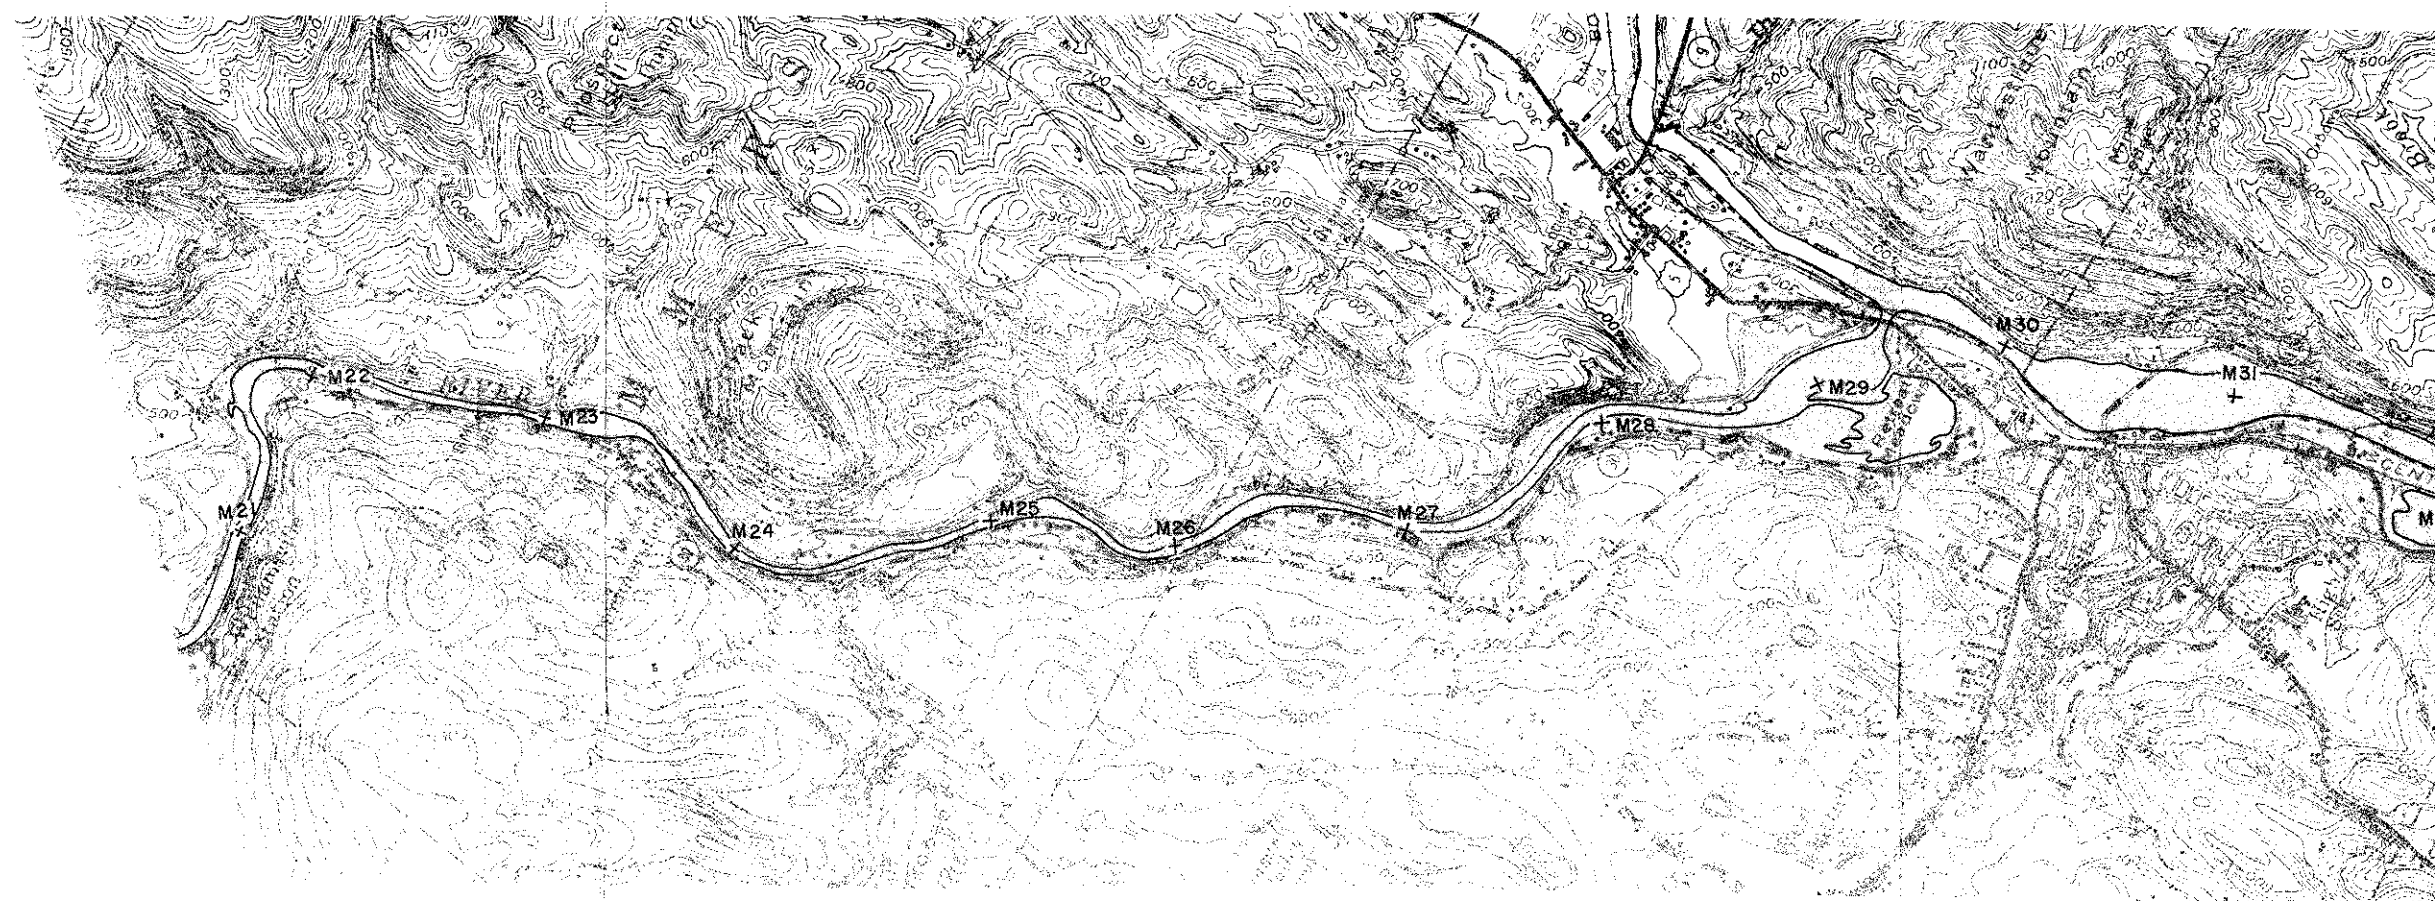
PLATE 7-12c

RIVER MILES DOWNSTREAM FROM BALL MOUNTAIN DAM

When failure has occurred or is imminent, the Project Manager's first action should be to notify the Emergency Operations Center, who in turn will notify the local officials (Plate 7-3). As depicted on Plates 7-12a through 7-12d, the blue shaded areas indicate areas which could be inundated, assuming a hypothetical dam break at Ball Mountain Lake with pool full to spillway crest. Since a dam break and the ensuing events are a highly unpredictable happening to precisely quantify, the plates are presented to provide information for emergency planning of potential areas to be evacuated. The map reflects conditions of an extreme nature with a very small probability of occurring and does not reflect in any way upon the integrity of the dam.
